PROPERTY CONDITION ASSESSMENT

Virginia College
8150 Warren H. Abernathy Highway
Spartanburg, Spartanburg County, South Carolina

Blackstone Consulting LLC
Project No. CMSXPA016.02

December 15, 2010

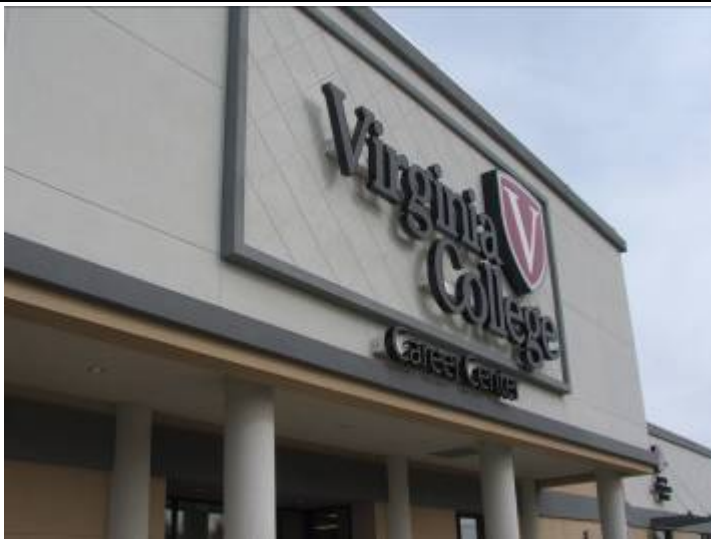
PHOTOGRAPH 1

Property identification signage and EIFS exterior at main entrance along the south elevation of the building

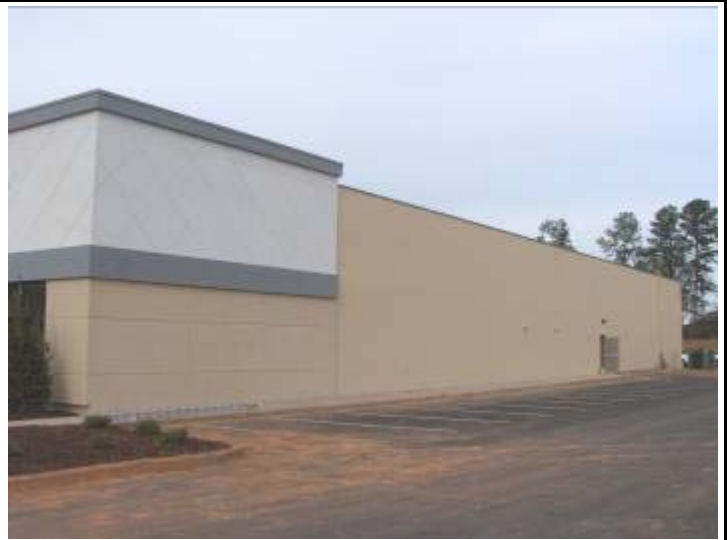
PHOTOGRAPH 2

East elevation of the building and typical EIFS and painted CMU exterior

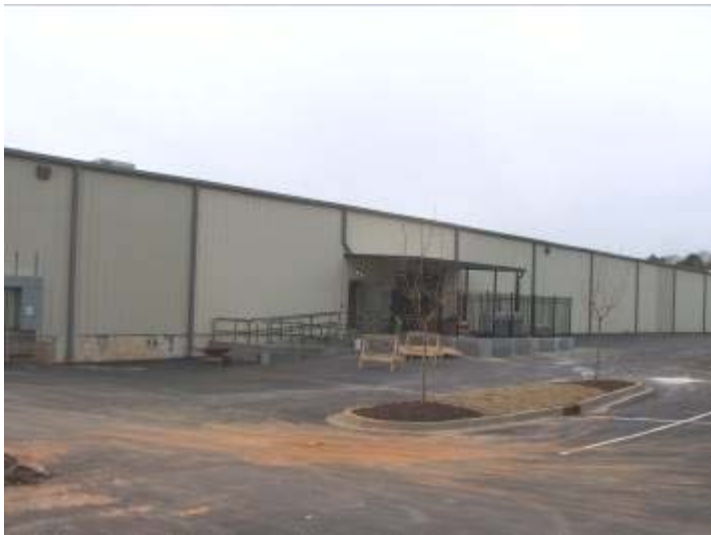
PHOTOGRAPH 3

North elevation of the building with exterior deck area and painted standing metal seam panel exterior

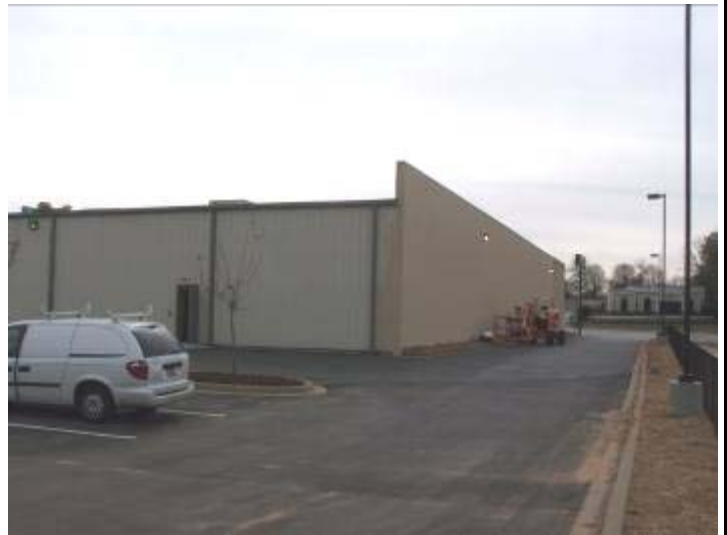
PHOTOGRAPH 4

West elevation of the building and service drive

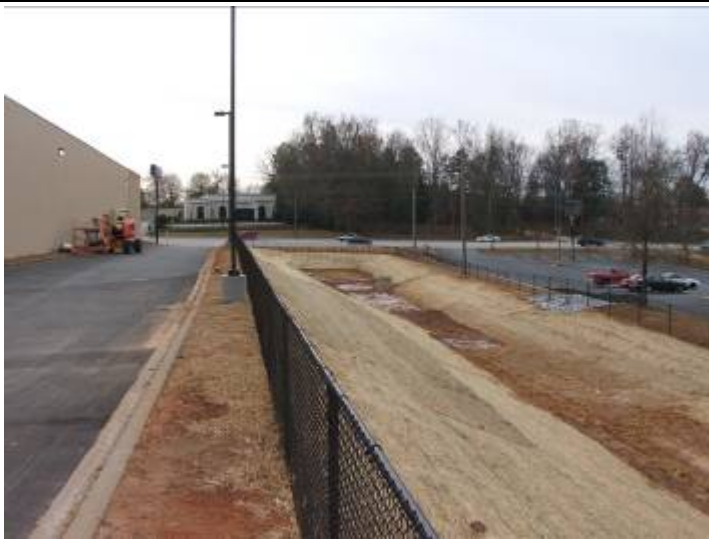
PHOTOGRAPH 5

Observations/Comments: Within the boundary, the site has a slight slope towards the west with a significant slope to the west at the stormwater retention area. The storm water system appeared to provide adequate drainage for the site. No areas of erosion or flooding were observed at the site. No storm water drainage problems were noted during the site assessment or reported by the site contact.

Storm water retention area on western portion of the site

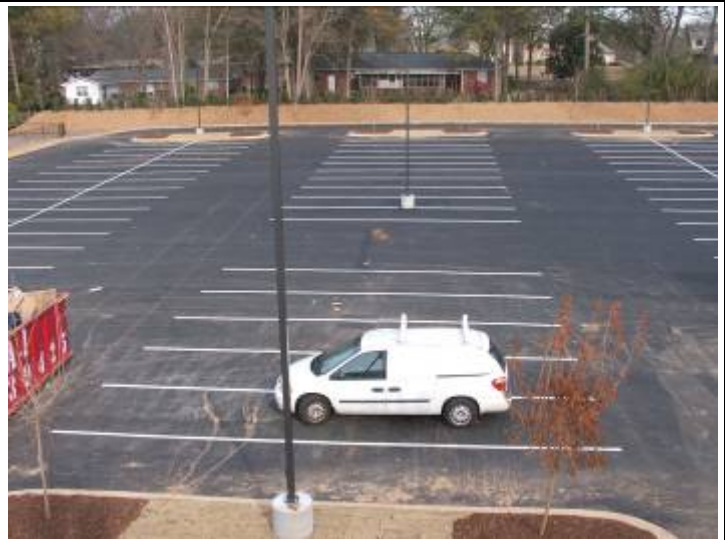
PHOTOGRAPH 6

Observations/Comments: Blackstone observed that the northern asphalt pavement was recently installed to create the north parking areas. The remaining asphalt pavement was

observed to have isolated areas of patches, repairs, sealcoating and striping that were noted to be in overall fair to good condition. Mr. Cornelison stated that the repairs, sealcoat and striping were recently performed in 2010; however, isolated areas remain to be completed due to construction staging. The remaining work is scheduled to be completed on December 17, 2010; therefore no costs have been included as part of this report.

Northern parking area; note striping not completed

In order to extend useful life, we recommend that a licensed contractor survey all asphalt pavement during the evaluation period and perform minor repairs as needed, seal all cracks, apply a sealcoat and restripe the parking stalls, and estimated costs for this work have been included in Table 2 - Capital Replacement Reserve Analysis (Table 2) provided in Appendix A.

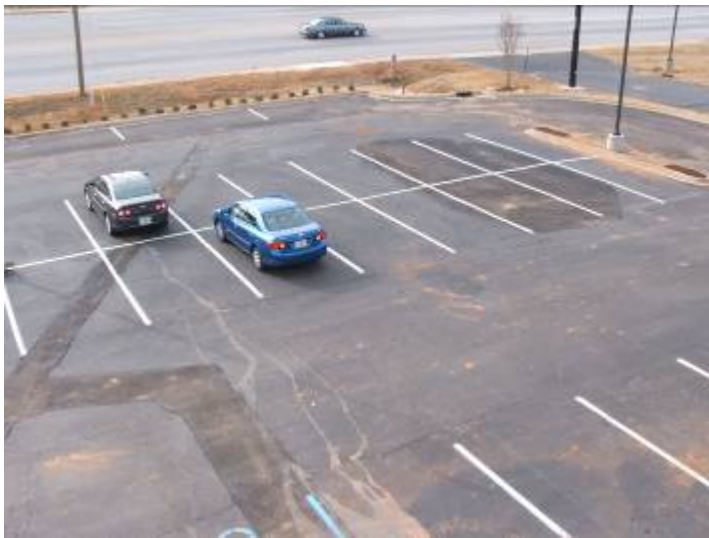
PHOTOGRAPH 7

Southern parking area and main access drive off of Warrant H. Abernathy Highway

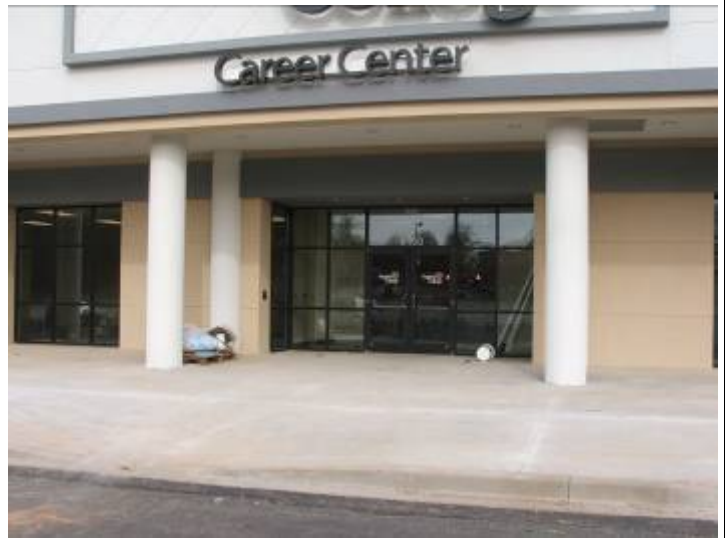
PHOTOGRAPH 8

The concrete sidewalks and curb areas were observed to be in generally good condition. The pedestrian pavement and concrete flatwork should be maintained as part of routine maintenance activities during the term.

Main entrance and typical pedestrian pavement

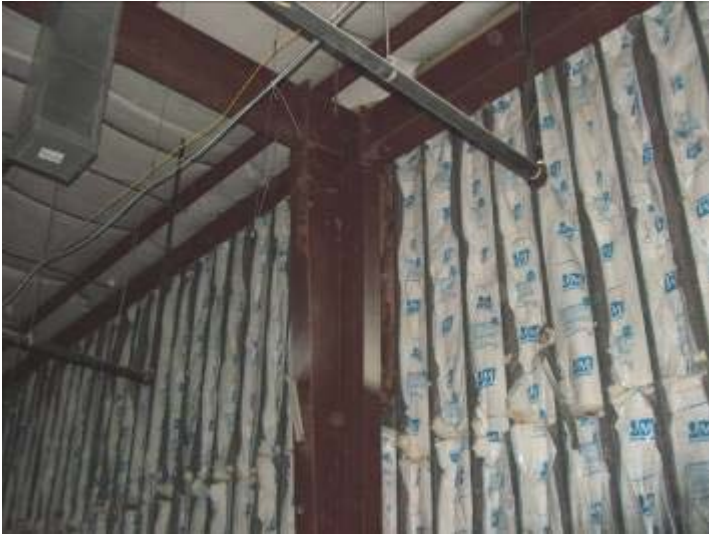
PHOTOGRAPH 9

Observations/Comments: The superstructure and framing were visible on a limited basis. No evidence of instability or movement was observed or reported. Routine maintenance is recommended during the term. It should be noted that no evidence of problematic fire treated sheathing was observed in the limited areas surveyed.

Metal structural framing observed in vacant tenant space

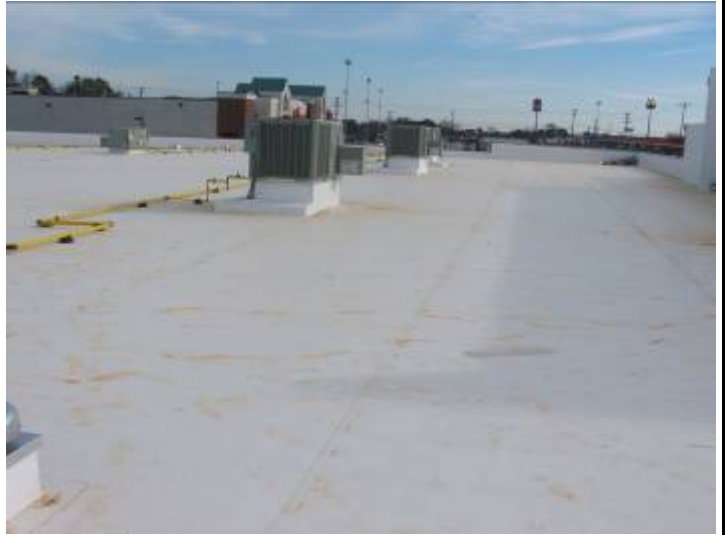
PHOTOGRAPH 10

Observations/Comments: The building roof system and roof covering were installed in 2010 and appeared to be in good condition. Based on the estimated useful life (EUL) of this type of roof system (approximately 20-years with proper maintenance), we do not anticipate any replacements during the evaluation period providing proper maintenance is performed. Management should periodically inspect and repair the roof systems (including flashing systems) as part of general routine maintenance during the term. Transfer of the roof warranty to CMS Companies should also be performed as a condition of this transaction.

TPO membrane roof coverings

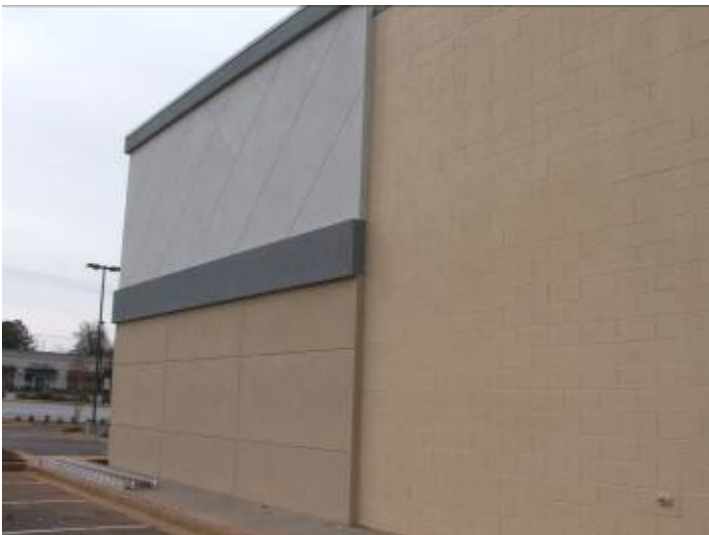
PHOTOGRAPH 11

Observations/Comments: The exterior walls appeared to be in overall good condition, and no areas of damage or deterioration were observed that would require immediate repair. Periodic power washing, painting and repairs associated with the facade are recommended during the evaluation period and replacement reserves for this work are included in Table 2.

View of exterior EIFS and painted CMU

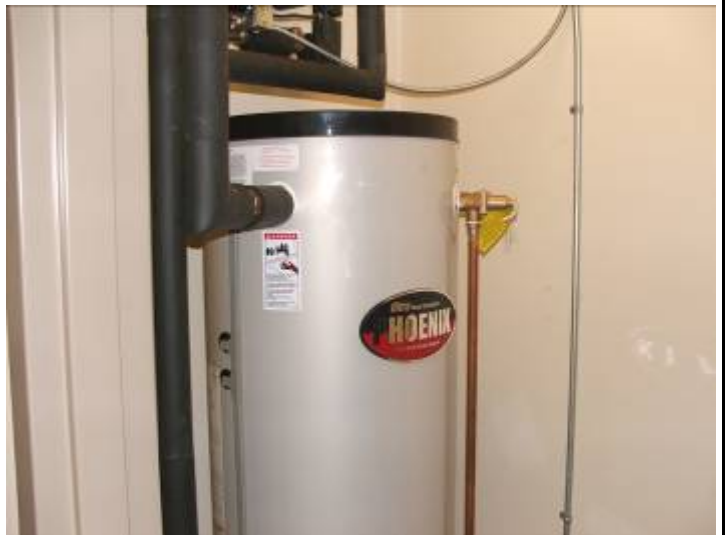
PHOTOGRAPH 12

Observations/Comments: The water heaters are in new condition and should be maintained as part of routine maintenance activities during the term. No replacement reserves have been included as part of this report (reported to be the tenant's responsibility).

Gas-fired water heater in Cosmetology area

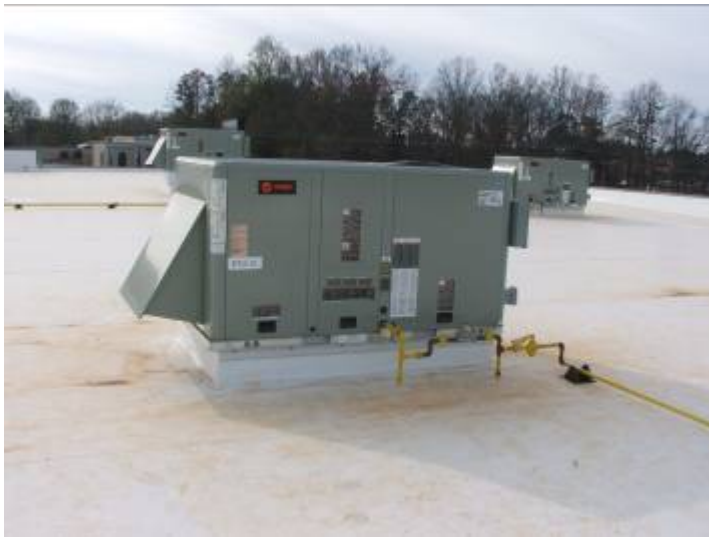
Observations/Comments: The heating and cooling equipment observed appeared to be in good operational condition. According to the site contact, the tenant (Virginia College) is responsible for the maintenance and replacement of the HVAC equipment during the duration of the lease. In the event of an unplanned vacancy (not anticipated), since the units are new no replacements are anticipated during the evaluation period providing proper maintenance is performed.

PHOTOGRAPH 13
Recently installed Trane brand roof mounted
HVAC unit

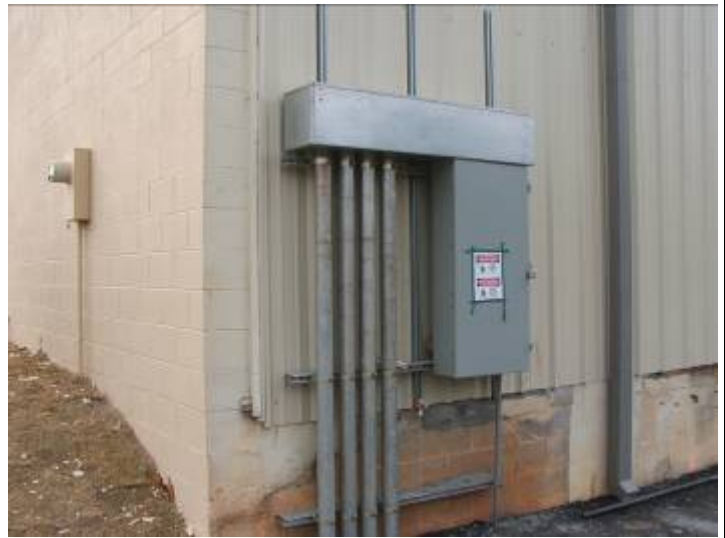
Observations/Comments: The electrical power systems appeared to be adequate based on the building's use. The switchgear, subpanels and electrical meters observed appeared to be in good operational condition. No electrical problems were noted during our site assessment or reported by management.

PHOTOGRAPH 14
Recently installed electrical service

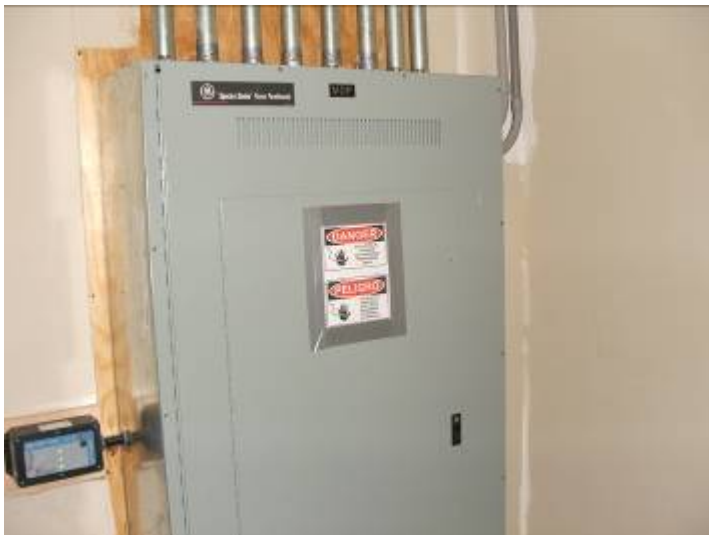
PHOTOGRAPH 15
Main electrical panel

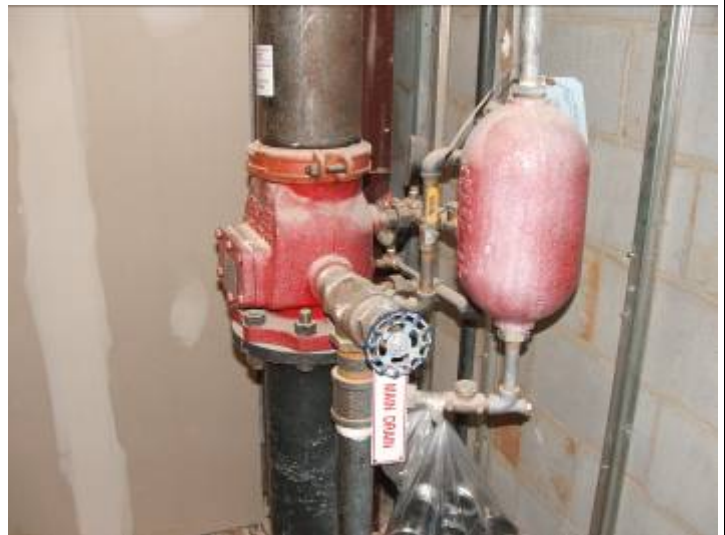
Observations/Comments: The fire protection system components observed appeared and were reported to be in good condition and recently installed. The AFSS systems were inspected by Century Fire Protection Palmetto in December 2010, the alarm system was in the process of a final inspection by Simplex Grinnell during the site survey, and the fire extinguishers were installed by Carolina Fire Services in October 2010. Typically, the annual inspection of these systems is a tenant responsibility and should be performed as tenant responsibility or as routine maintenance during the evaluation period.

PHOTOGRAPH 16
Fire suppression equipment

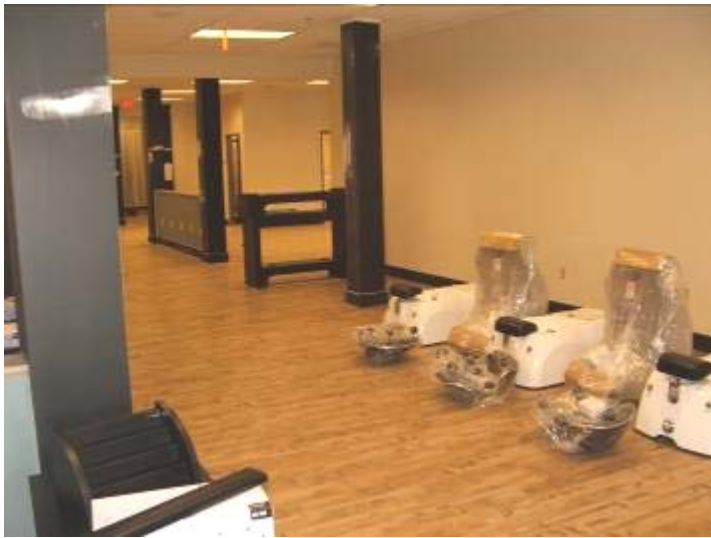
PHOTOGRAPH 17
Interior finishes of Cosmetology area

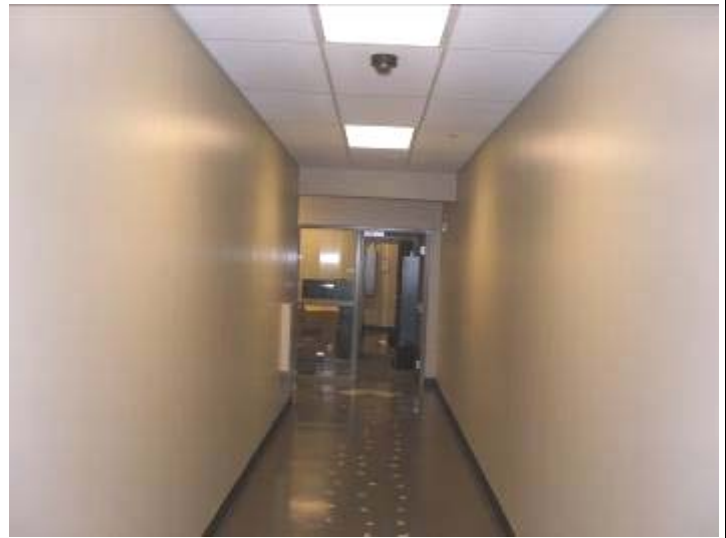
PHOTOGRAPH 18
Typical common corridor interior finishes

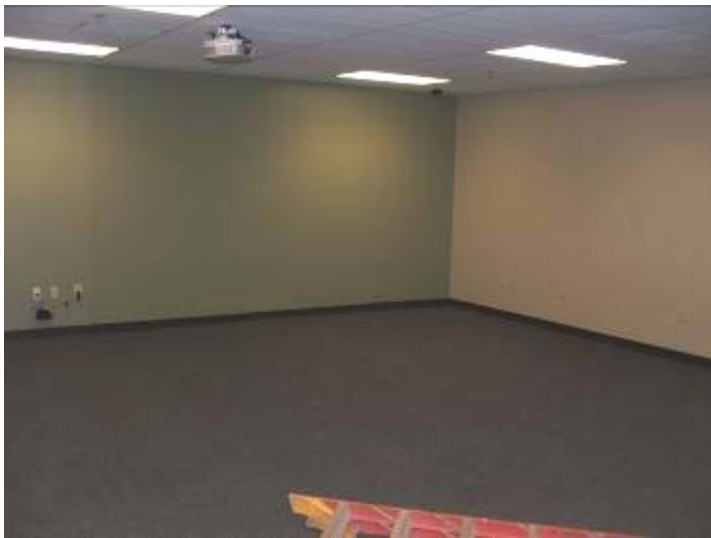
PHOTOGRAPH 19
Typical classroom interior finishes

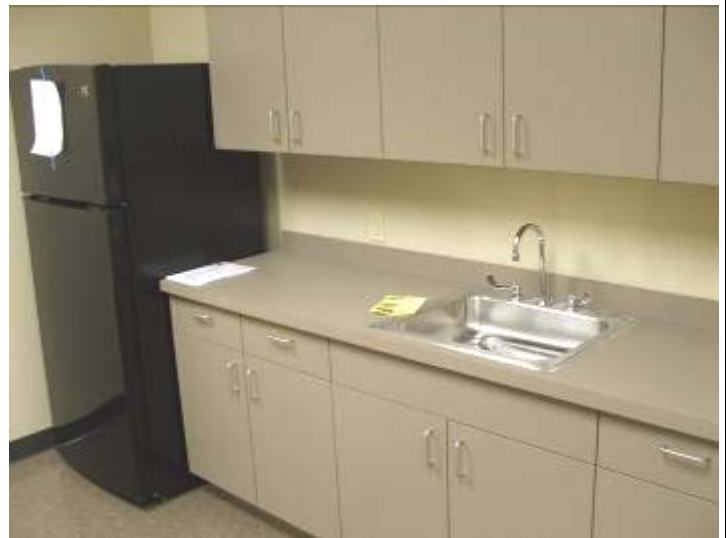
PHOTOGRAPH 20
Employee lounge interior finishes
